THE WIRE OF DEATH

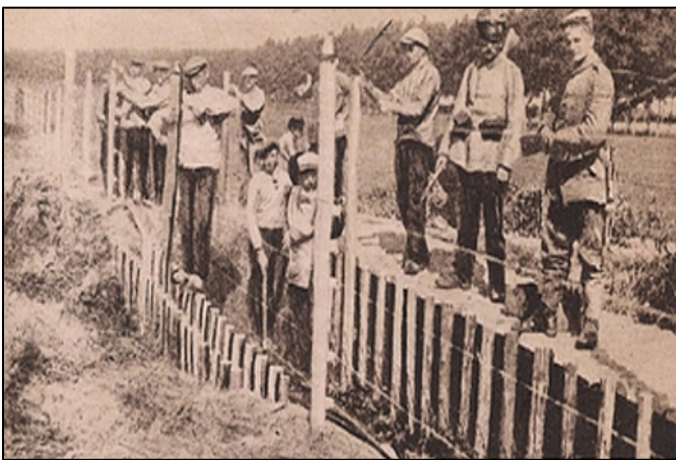
Large stakes were driven in the soil on the route that was layed out. The pine stakes were equipped with porcelain insulators to hold the wires. The fence usually contained five or six wires, spaced evenly at 30 centimetres, fixed at the Belgian side of the stake. Higher up two more wires were placed to supply the electricity (the 'Speiseleitung', as the Germans called this feeder wire). Smooth wire of three to five millimetres diameter was used, but supplies were insufficient so often barbed wire was used instead. One and a half up to three metres along either side of the fence another barbed wire fence was placed. These were lower, not electrified, serving as a protection for people and animals.

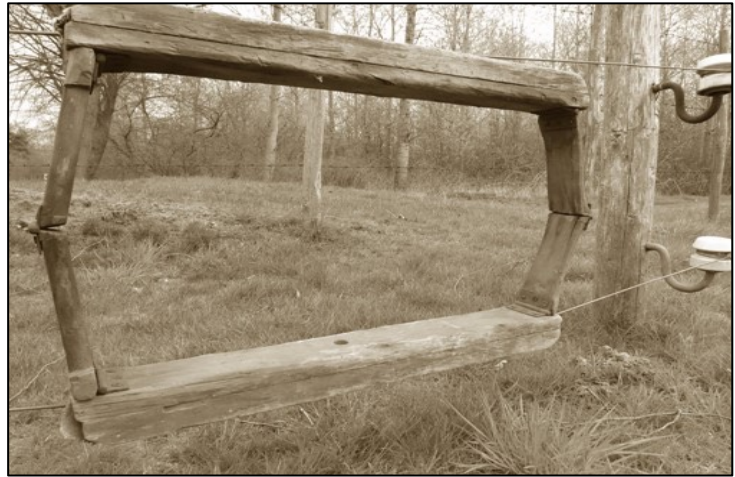
Gadgets were developed to defeat the electric fence. This wooden frame, which separated the wires and through which an agent might carefully climb, however, there were also many victims: more than 1,000 persons have been listed so far as having died at the fence, whether by electrocution or by having been shot by the guards. After the armistice, the fence was immediately demolished by the locals, leaving no traces of the deadly wires.

While it deterred many from crossing, as well as large groups of Belgian males of military age, it was not impenetrable. Determined spies and smugglers developed methods of crossing the electric barrier. Some used rubber-lined barrels and window panes, which they would (carefully) insert between the wires and crawl through; some dug under the wires or short-circuited them, some used wooden ladders. Sometimes, contraband or documents could just be thrown over to the other side. The Germans countered by burying live wires and raising the height of the fence and installing searchlights.

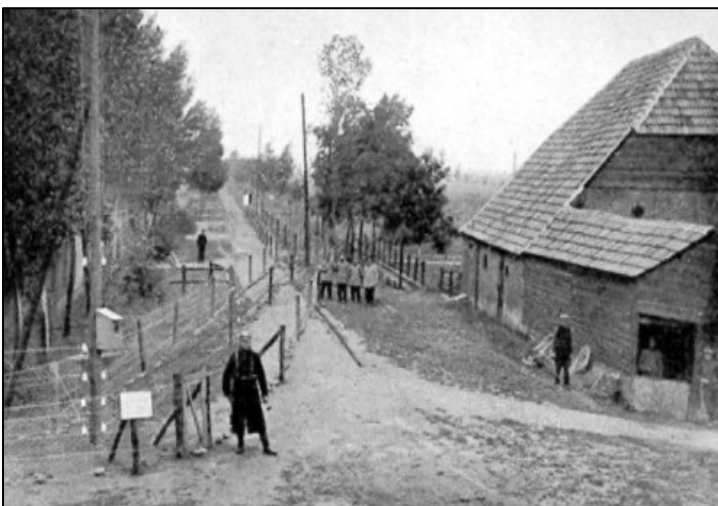
The high voltage border obstacle on the Belgian Dutch border of 1915-1918 from the Dutch side.

As mentioned previously, construction began in the spring of 1915 and consisted of over 200 km (125 miles) of 2,000-volt wire with a height ranging from 1.5 to about 3m (5 to about 10ft) spanning the length of the Dutch-Belgian border from Aix-la-Chapelle to the River Scheldt. Within 100–500m (110–550yd) of the wire, anyone who was not able to officially explain their presence was summarily executed.

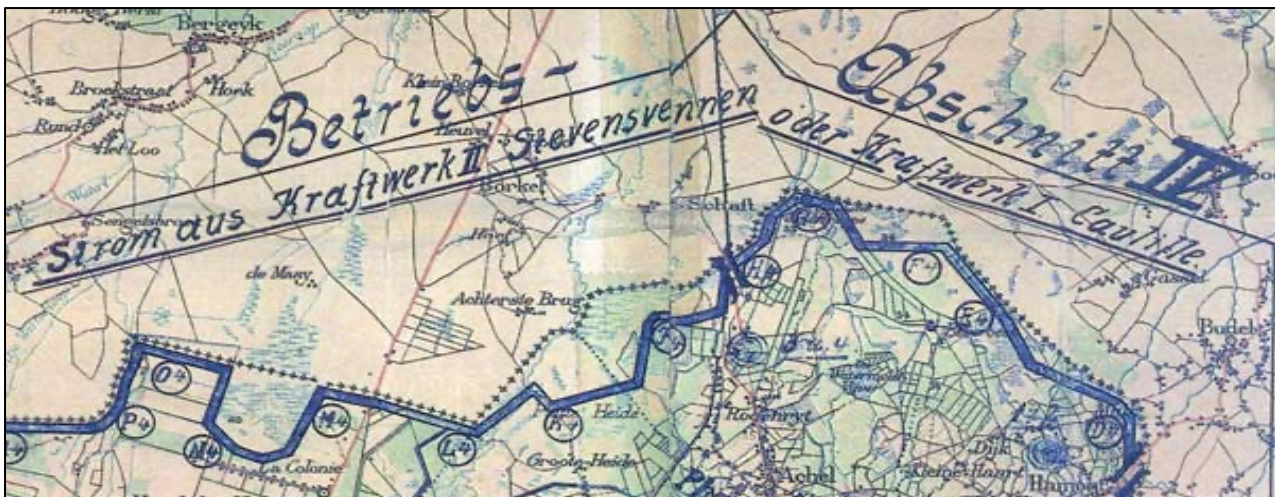
A German military map of a part of the Belgian-Dutch border (near the Belgian villages of Achel and Neerpelt). The map shows the Electric Fence and also where the current came from. Different *Kraftwerke* (power stations) along the line supplied the 2000 Volts.

Belgium did not yet have power stations, only a few companies had the equipment to generate electricity to supply in their own needs. The region of the Voer and the south of Limburg relied on the transformer kiosk of Reutershag (between Vaals and Aachen), that had a feeder cable to Belgium. The region between Kanne and Maaseik relied on the same power station, as well as on the equipment of the gunpowder factory in Kaulille and the sawmill of the Emsens family in Lommel-Stevensvennen. The Germans made use of the same plants in the north of Limburg to supply the regions of Maaseik to Lozen and further to Lommel-Stevensvennen. The electricity in the region Lommel-Stevensvennen to Minderhout was supplied by Kaulille, Lommel-Stevensvennen and a transformer kiosk in Kapellen. For the western region of the Schelde, sources are less clear. It seems some smaller companies near to the border with Zeeuws-Vlaanderen supplied electricity: an electrical substation in Zelzate, a factory in Moerbeke, etc.
